Best Practice Excursion "Gangbach" (Schächental, Uri)

Karl Grunder¹⁾, Roland Stalder¹⁾, Christian Rickli²⁾, Frank Graf³⁾

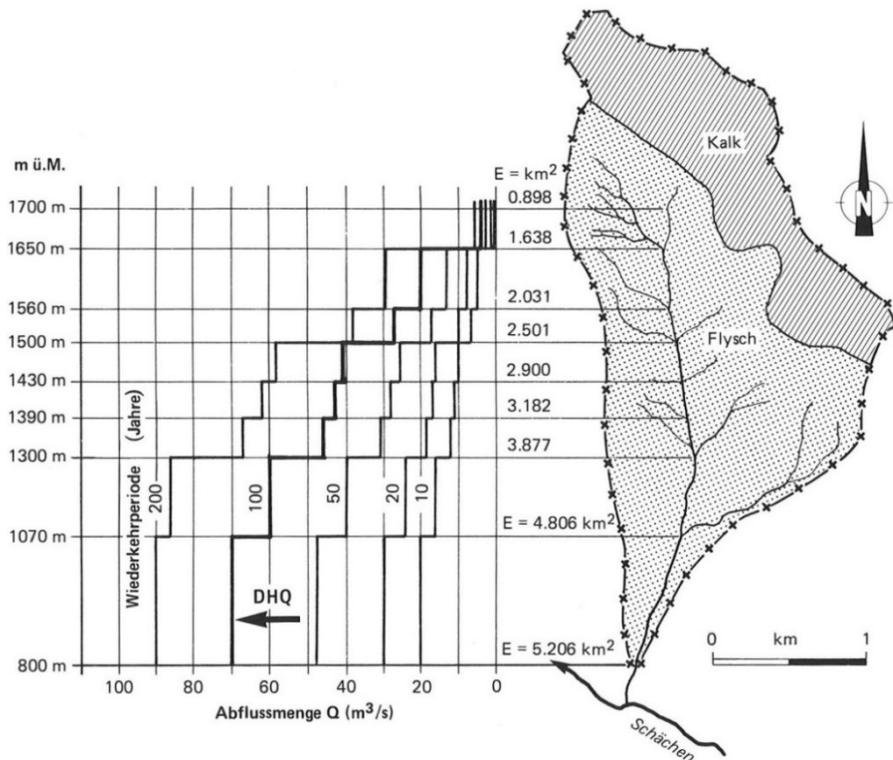
Fig. 1: Geology, network of watercourses, and design floods of the "Gangbach" (WSL 1987).

The upper part of the "Gangbach" catchment is characterised by steep rock faces of "Quintener" limestone and permeable screes. In the main part of the catchment that is formed by soft rock, in particular by "Wildflysch" shale, a densely branched network of watercourses has been developing. In the lower part of the catchment native limestone and roof slate are dominating (Fig. 1). Hydrology plays a key role in the catchment processes: in the upper part of the catchment water tends to infiltrate completely. Towards the bottom part of the catchment water is springing up causing shallow landslides which often evolve into mud flow or provoke deep seated landslides.

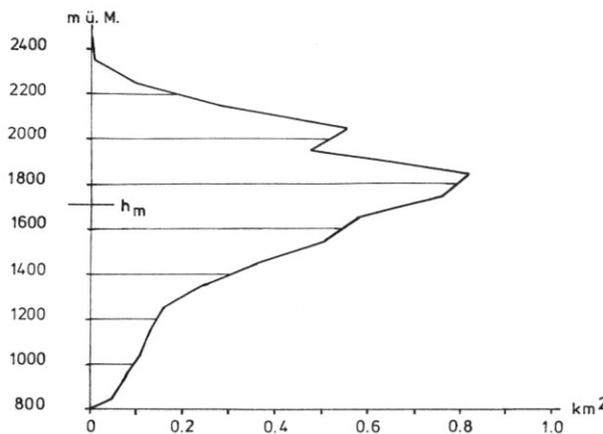
The area centroid of the "Gangbach" catchment is on an average altitude of 1700 m asl (Fig. 2).

Fig. 2: Absolute distribution of altitude in the "Gangbach" catchment (Forest Service Uri/Forest and Hunting, 1982).

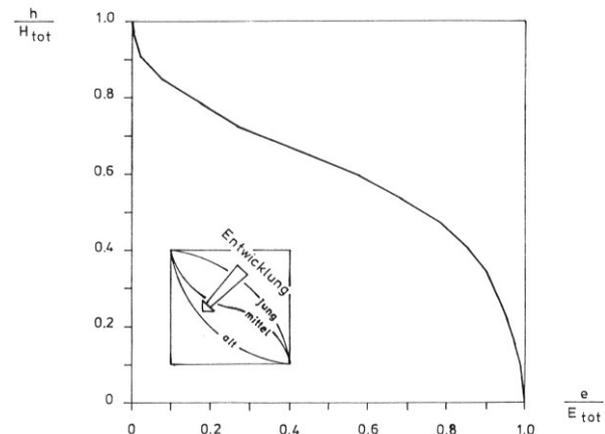
The relative altitude distribution of the "Gangbach" catchment is distinctly convex and the age of development only approaching the medium stage. Therefore, the tendency for further deepening of the channel is still considerable (Fig.3).

Fig. 3: Relative distribution of altitude in the "Gangbach" catchment (Forest Service Uri/Forest and Hunting, 1982).

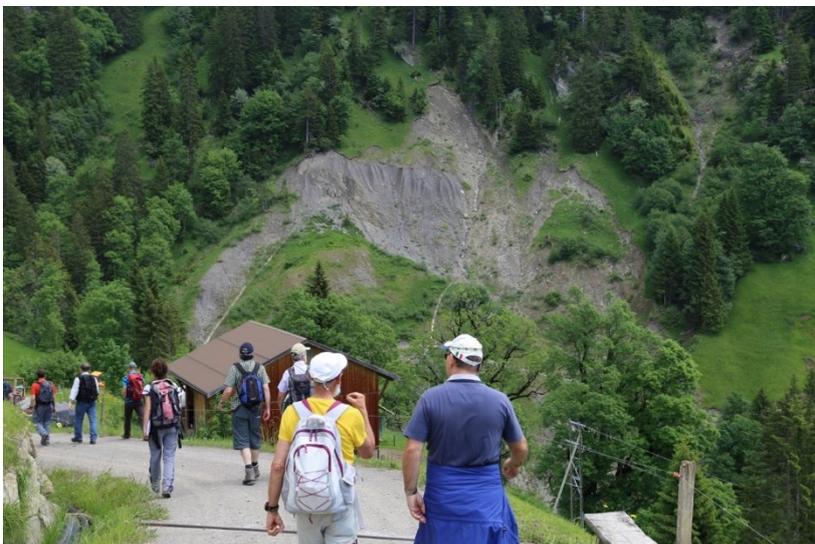
The "Lotter" landslide, main debris source of the 2005 event

- **Landslide "Lotter":**
For a long time active area of medium- to deep-seated landslides.
Largest landslide in the valley of the "Schächen" during the heavy rainstorms in 2005 with tremendous consequences on the bed-load discharge of the "Schächen".
Combined with stabilising log crib-walls and drainage measures, the re-colonisation with protecting vegetation of areas affected by landslides plays a central role in torrent control and, particularly, in order to prevent bed-load transport. Currently, the maintenance measures are restricted to technical constructions (i.e. cleaning of the drainage channels) and do not consider care and maintenance of vegetation.

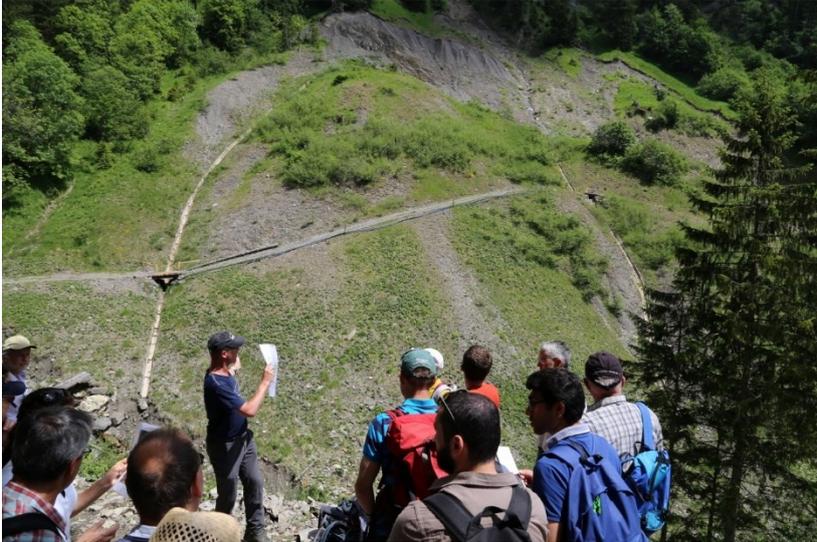
Beat Annen explains the principles of combined stabilisation measures related to the "Lotter" landslide
